WHY MASONRY?

CASE
STUDY

A SUSTAINABLE RENOVATION: THE SANTA FE SPRINGS LIBRARY

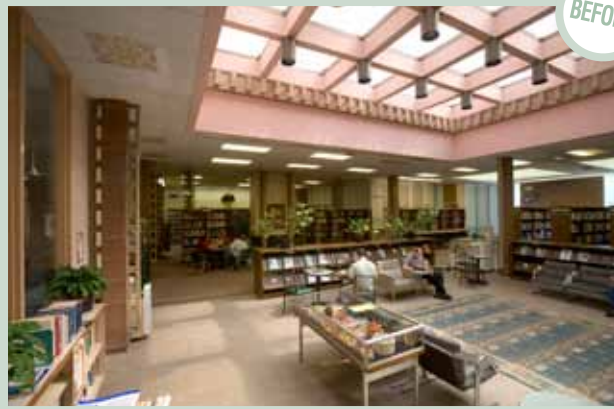
BEFORE

Seven years ago, with high hopes, the City of Santa Fe Springs applied for a State Bond Grant. They envisioned using the monies from the grant to build a beautiful, new \$17 million library – desperately needed since their current facility was constructed in the 1960s.

Typically a renovation is a much more sustainable solution and given the city’s fiscal constraints, they decided to stay put and reimagine the existing library. From the beginning the design team knew that maintaining the existing concrete blocks would be a good design strategy. Not only were they in good condition but the scale, texture and color of the blocks would create an excellent background for the new library improvements.

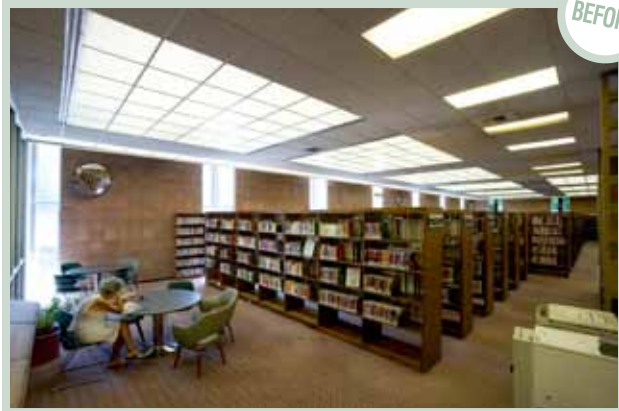
BEFORE

1. Maintain existing openings at the perimeter while replacing existing single-pane glazing with new high performance glass, and upgrading roofing insulation to create a more efficient envelope. The only new exterior opening was for a double-store front door which connects the library with its garden expansion. Clever structural engineering work by LPA Engineer Daniel Wang made this requirement a reality for the

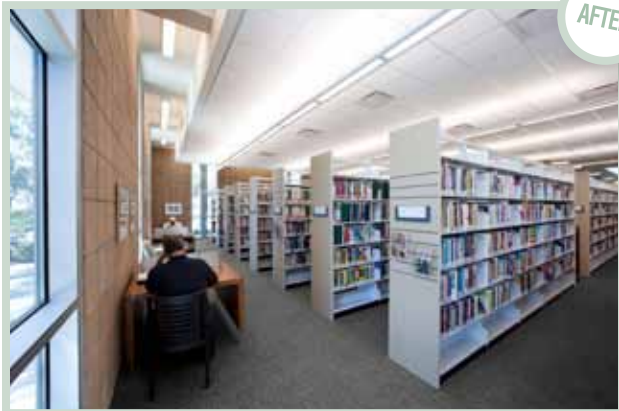
AFTER

project. The improvements made to the building's envelope and lighting made for a more energy efficient library, with fewer utility costs.
